Contract #: 04-0120F4Cty: SF/ALA Rte: 80 PM: 13.2/13.9File #: 69.28**WELDING INSPECTION REPORT****Resident Engineer:**Pursell, Gary**Address:** 333 Burma Road**City:** Oakland, CA 94607**Report No:** WIR-004141**Date Inspected:** 30-Aug-2008**Project Name:** SAS Superstructure**OSM Arrival Time:** 700**Prime Contractor:** American Bridge/Fluor Enterprises, a JV**OSM Departure Time:** 1730**Contractor:** Zhenhua Port Machinery Company, Ltd (ZPMC), Changxing Island **Location:** Shanghai, China**CWI Name:** Keng Chan**CWI Present:** Yes No**Inspected CWI report:** Yes No N/A**Rod Oven in Use:** Yes No N/A**Electrode to specification:** Yes No N/A**Weld Procedures Followed:** Yes No N/A**Qualified Welders:** Yes No N/A**Verified Joint Fit-up:** Yes No N/A**Approved Drawings:** Yes No N/A**Approved WPS:** Yes No N/A**Delayed / Cancelled:** Yes No N/A**Bridge No:** 34-0006**Component:** OBG and tower**Summary of Items Observed:**

Bay 4**Double Diaphragm Assembly 33meter**

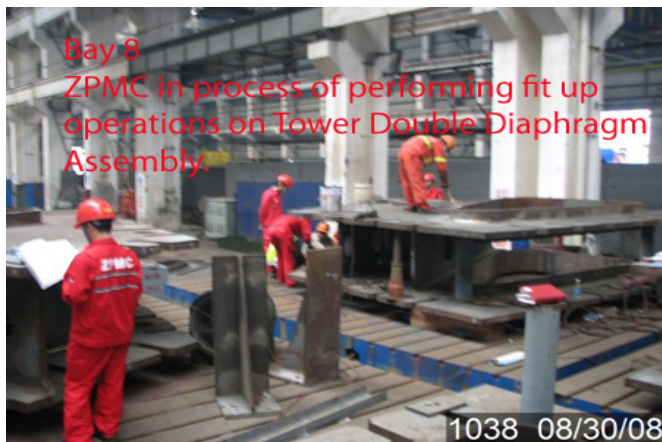
Bay 8

The Quality Assurance Inspector observed ZPMC performing fit up operations on various double diaphragm assemblies.
